# Manhole Inspection Summary

Manhole # S33EE\_017MH

Insp Date: **2/27/07 1:22 PM**

**Location** Address: **1020 PARK AVE**

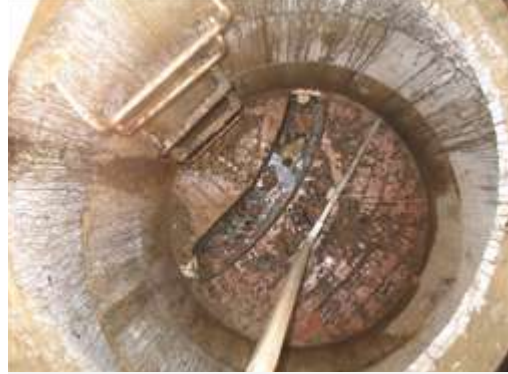
Top View

☒ **Evidence Of Surcharge**

Depth: **1.5** (ft.) ☐ Active Surcharge Present

Evidence of surcharge - Bench debris.  
Channel debris.

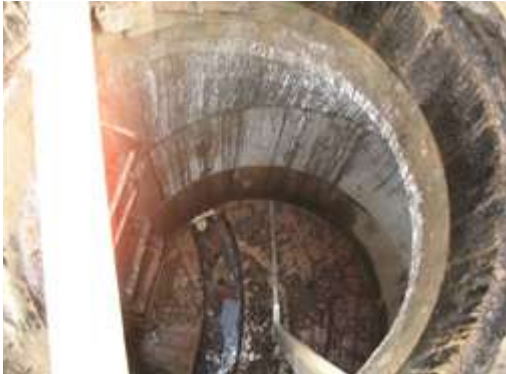
Defect

Condition: ☐ Sound ☐ Cracked ☐ Root Intrusion ☐ Loose Brick ☒ **Deteriorated**

Infiltration: ☐ None ☒ **Joint** ☐ Cracks ☒ **Mortar** ☐ Roots ☐ Wall

Frame leaks. Adjustment deterioration,  
loose brick and infiltration. Barrel  
infiltration.

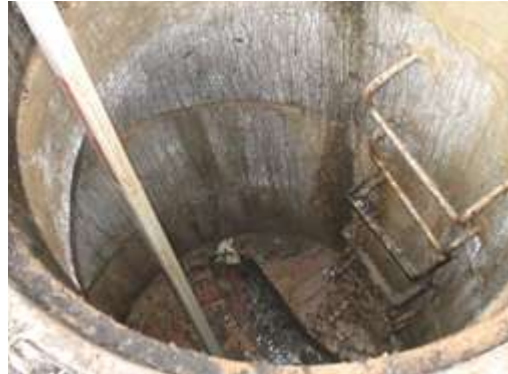
Defect

Infiltration: ☐ None ☒ **Joint** ☐ Cracks ☐ Mortar ☐ Roots ☐ Wall

Infiltration: ☐ None ☒ **Joint** ☐ Cracks ☐ Mortar ☐ Roots ☒ **Wall**

Adjustment, Corbel and Barrel infiltration -  
other side.

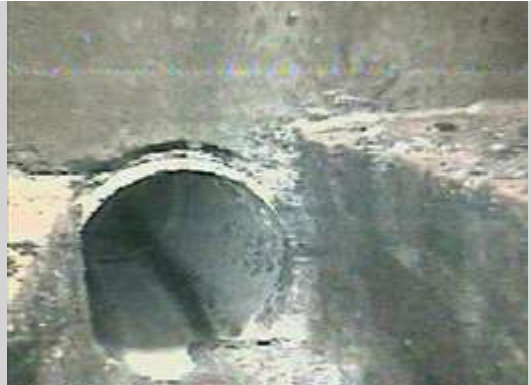
### 8 in. Circular Gravity Sewer Pipe Out @ 12 O'Clock

Infiltration: **Evidence** Pipe Seal Cond: **Unknown**

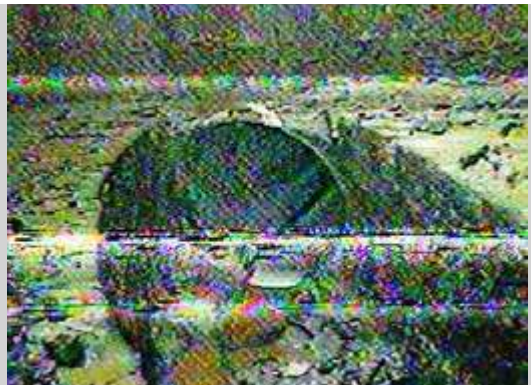
### 8 in. Circular Gravity Sewer Pipe In @ 8 O'Clock

Infiltration: **Evidence** Pipe Seal Cond: **Unknown**
